CAM Mis-position 09:?? Error (Rio 2 / Tango 2 / Avalon / Rio 2e / Tango 2e / Tango +L)

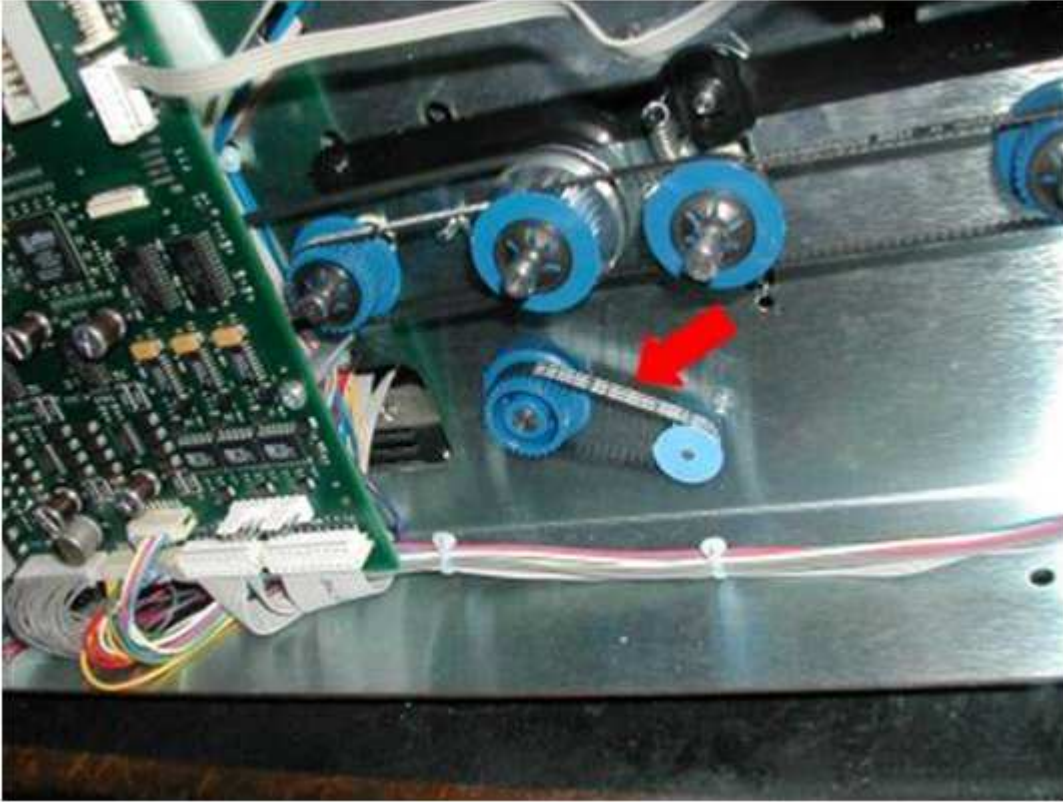
The **CAM** drive is shown below;

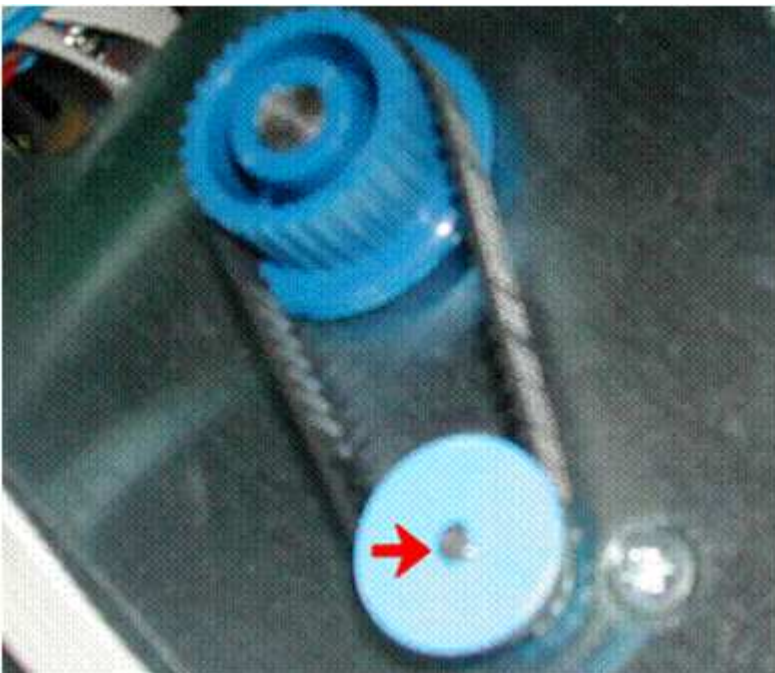
This is as it should look normally;

You can clearly see the shiny end of the motor shaft protruding from the pulley.

Refit it as in the picture above.

Check that the cam motor pulley (the smaller one) is pushed fully on to the motor shaft.
The end of the motor shaft should just protrude from the pulley (see above).

The pulley is only designed to be fitted once. You can by all means push it back onto the motor shaft as a temporary repair.

Add a drop of superglue on the end of the shaft to prevent the pulley falling off again.

However, as a permanent repair, we can send you a **new replacement pulley**.

This simply pushes onto the cam motor shaft as shown above.

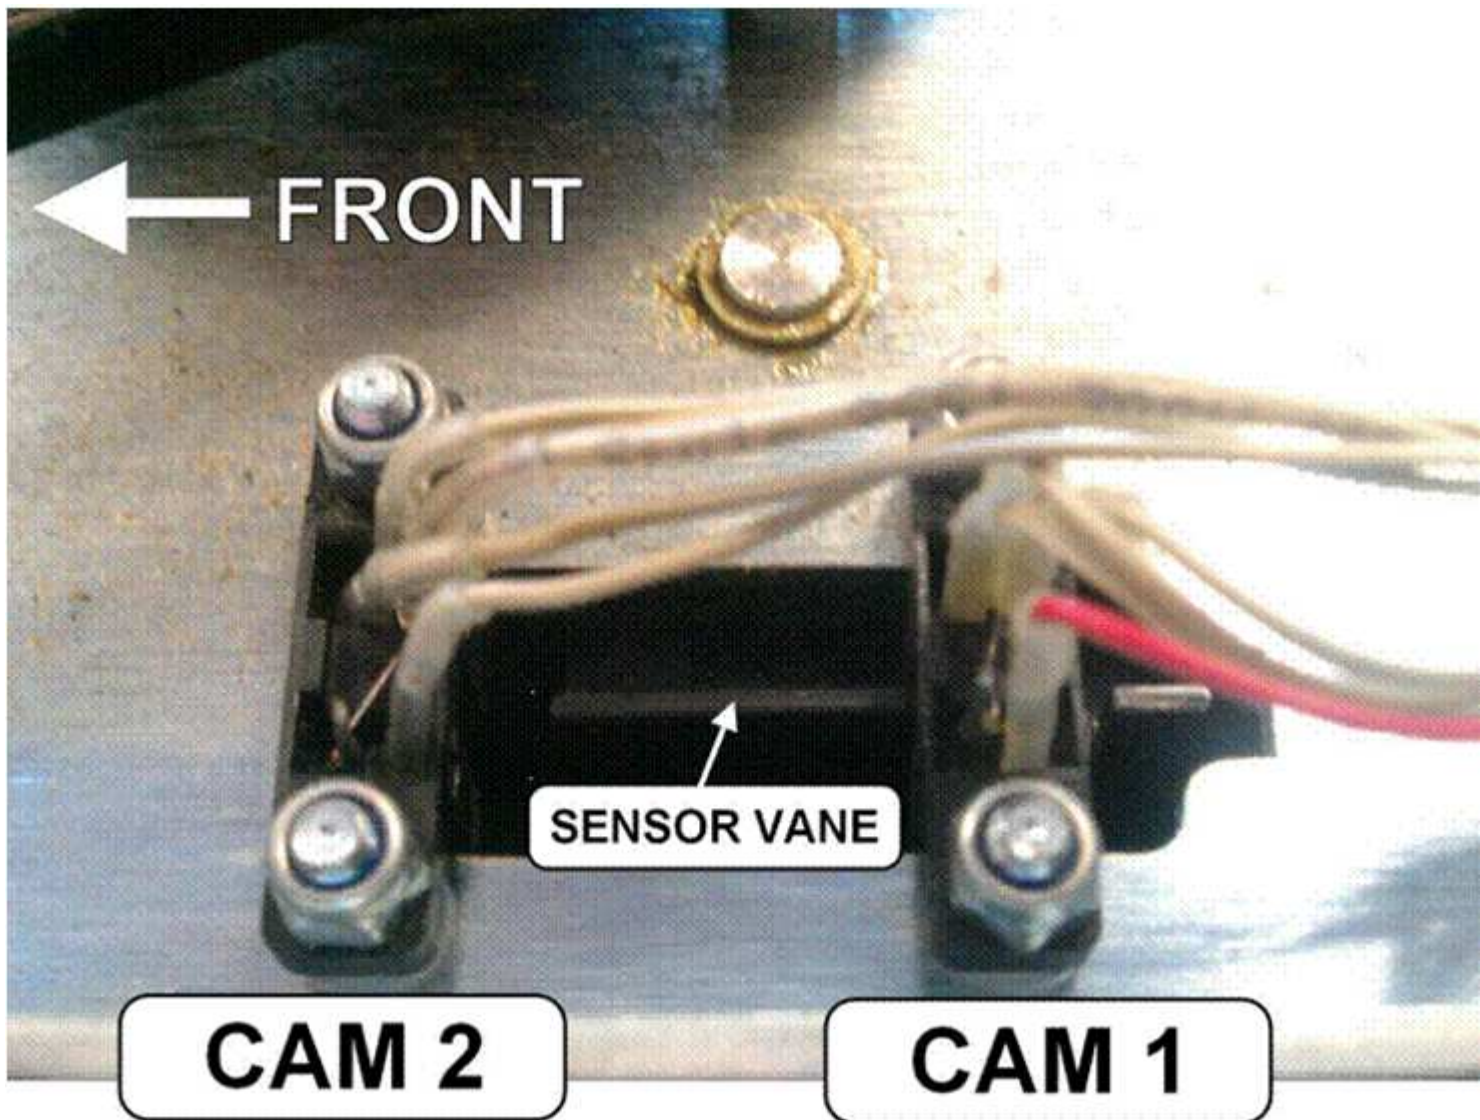
There are two thru-beam opto sensors for the printhead cam system;

CAM1 and CAM2.

These are located on the opposite side of the printer (right-hand side);

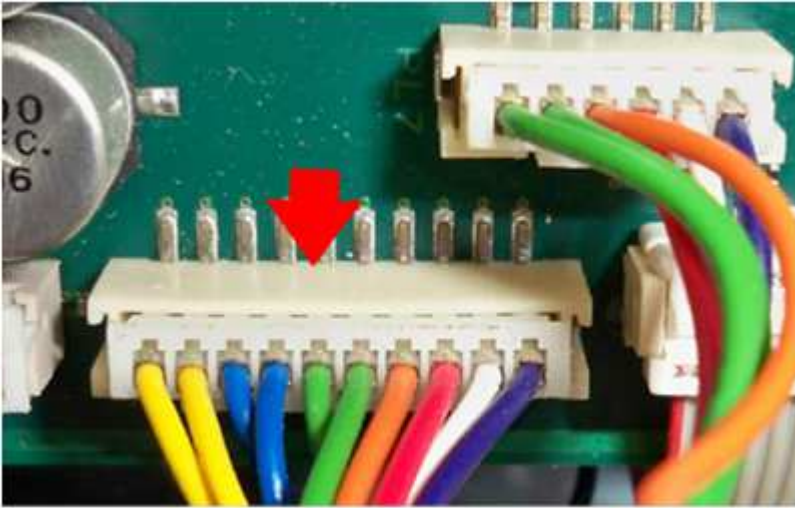
A rough check can be mad by disconnecting the motor power connector (PL8);

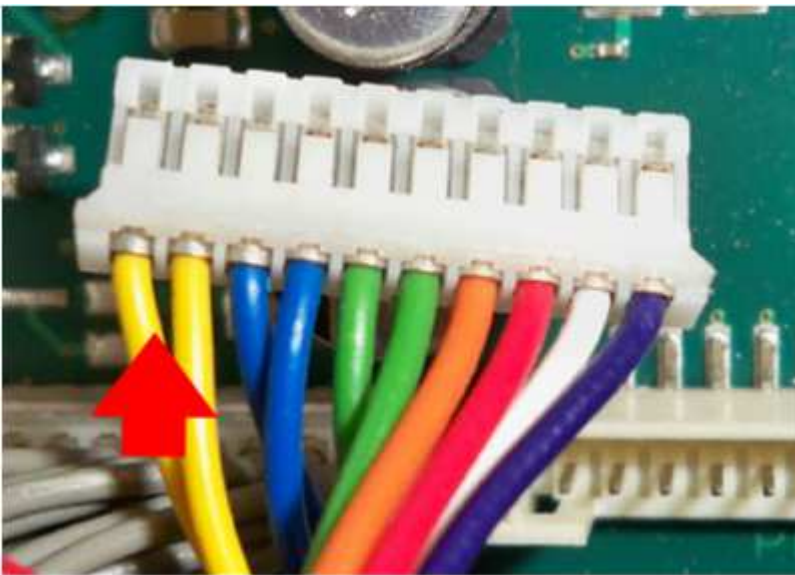
Then measure the resistance between the Yellow wires (CAM motor);

The resistance should normally be between 80 and 120Ω.
