CAM Mis-position 09:?? Error (Rio 2 / Tango 2 / Avalon / Rio 2e / Tango 2e / Tango +L)

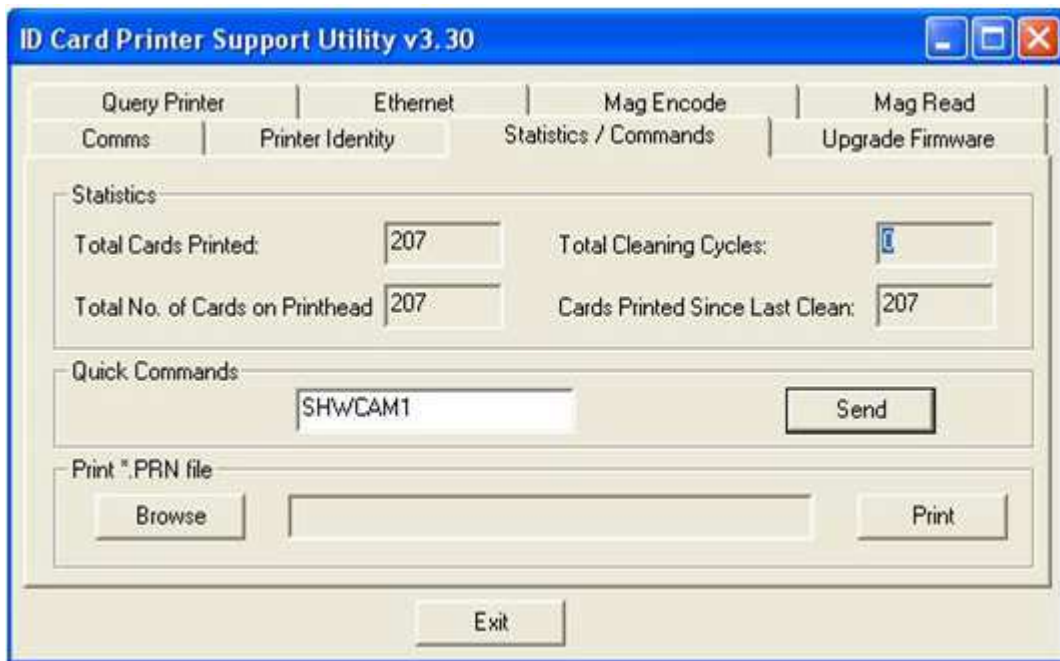
SHWCAM2 This will run the CAM motor. The printer's Green LED will go OFF when the vane blocks CAM 2 sensor.

If the **CAM motor is not running** when you send either the **SHWCAM1** or **SHWCAM2** command;

Remove the CAM drive belt.

In this case, the **CAM motor AND the control PCB should be replaced.**
